Water Leak Detection Report

Address: [REDACTED]

Date: Tuesday 25th October 2014

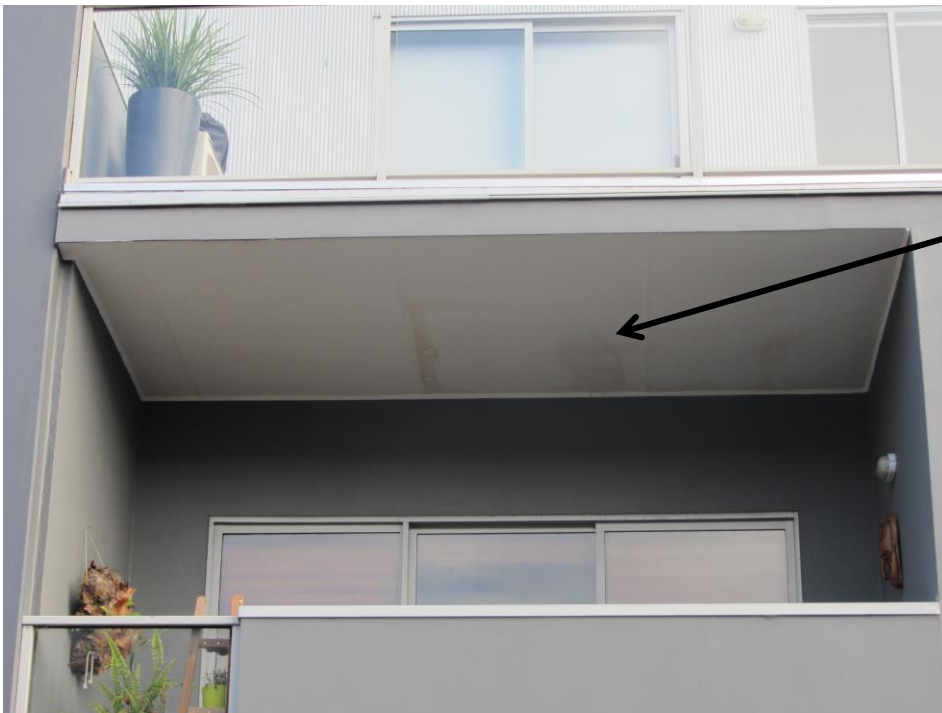
Picture of the Area tested.

Unit [REDACTED] is the top unit, with unit [REDACTED] underneath. In this photo you can see stains on the soffit of unit [REDACTED] caused by the water ingress.

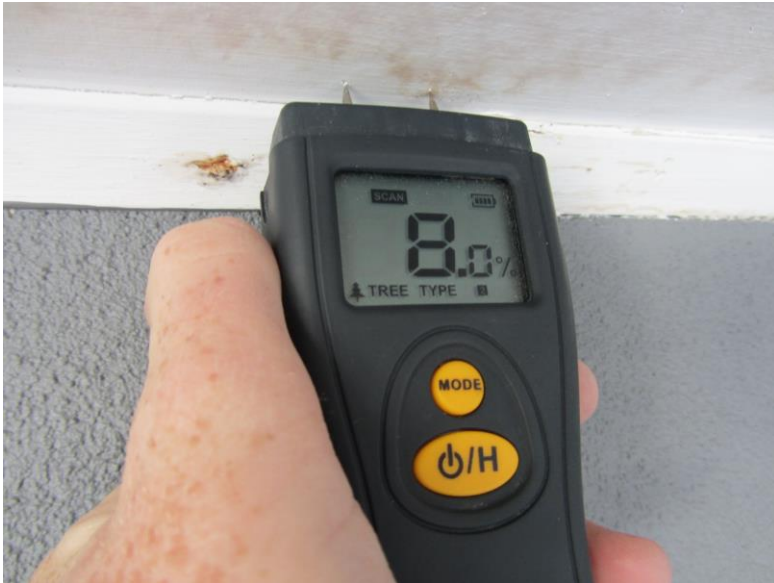
Photo 1.
Shows a moisture level reading
prior to testing beginning.

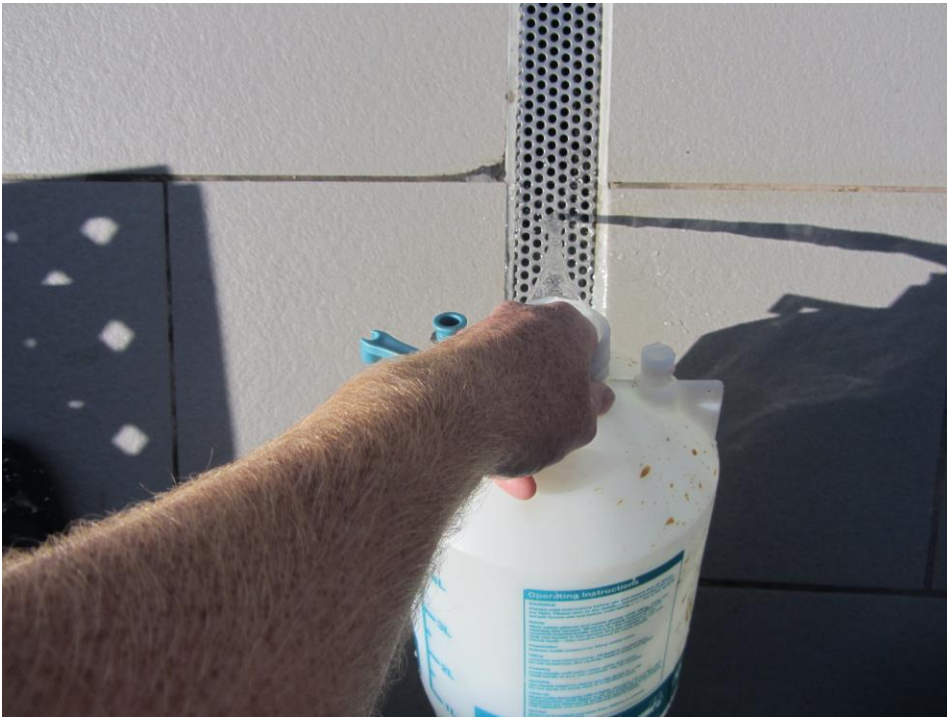
Photo 2.
Test 1 in progress.

No evidence of any leaks coming from this area was found after testing had been completed. Once this test had been completed [REDACTED], owner of unit [REDACTED] told me he has also previously poured water down this drain in an attempt to see if this is the source of the water leaks but had also seen no results. This provides further evidence that the trench drain is not the source of the water ingress.

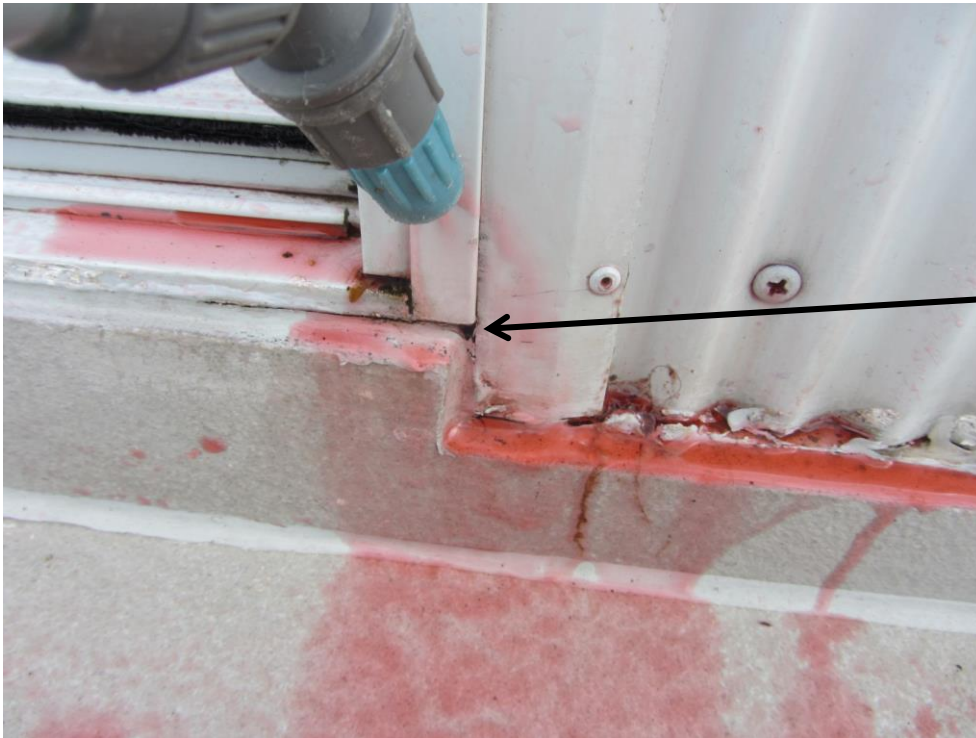
Test 2: [REDACTED] next used red dyed water to test the area of skirting tiles and the base of the door frame. In one particular area a small gap can be seen in the caulking between the tile and door frame and it is suspected that it's possible for water to enter through this gap which would then allow it to run down the back of the frame – behind the waterproofing membrane and into the soffit below.

Photo 3.
Test 2 in progress.
The small gap in the caulking can be seen here.

No red dye was found immediately following this test.

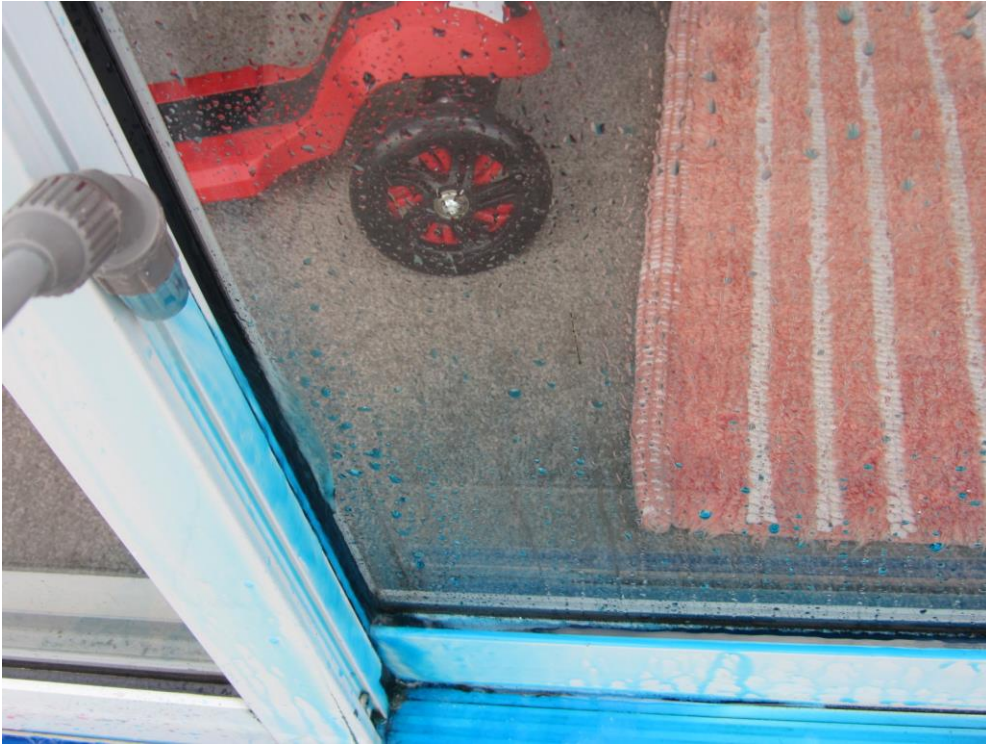
Photo 4.
Test 3 in progress.

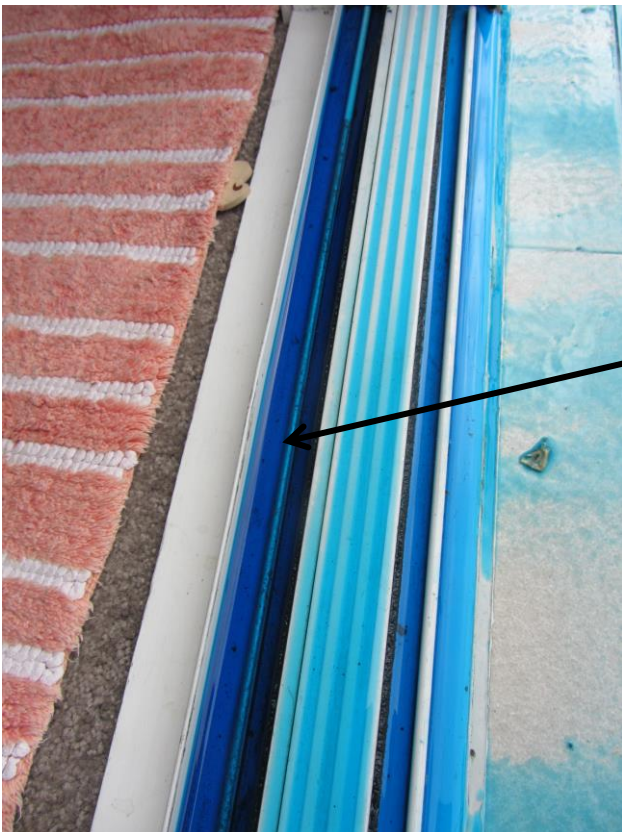
Photo 5.
Water can be seen in the door tracks.

During this test water could be seen pooling in the door tracks on the internal side of the frame, this shows that water is being trapped in the tracks of the door frame. This issue is exacerbated by the fact there appears to be no weep holes at the base of the door frame to allow this water to escape. After approximately 10-15 minutes the water would seep away through the frame.

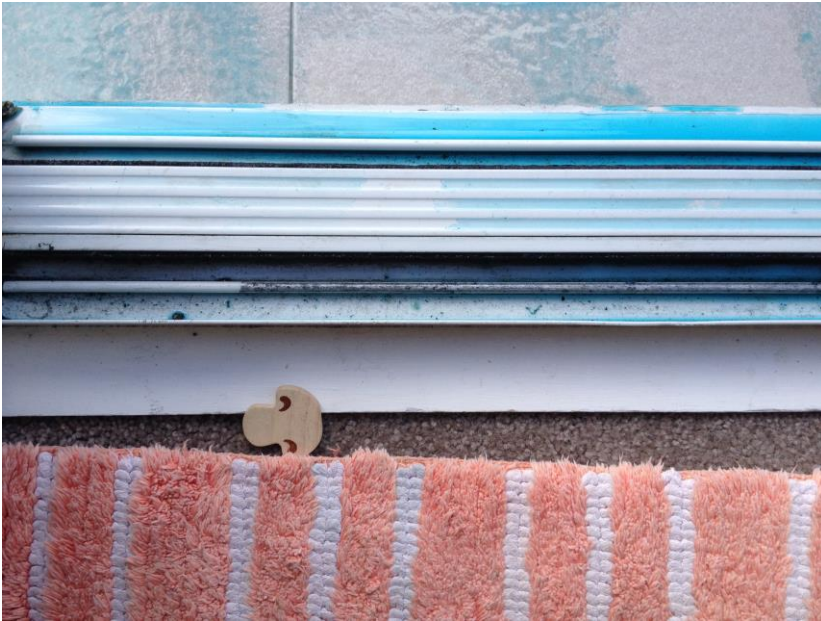
Photo 6.
Water has seeped away through the base of the frame.

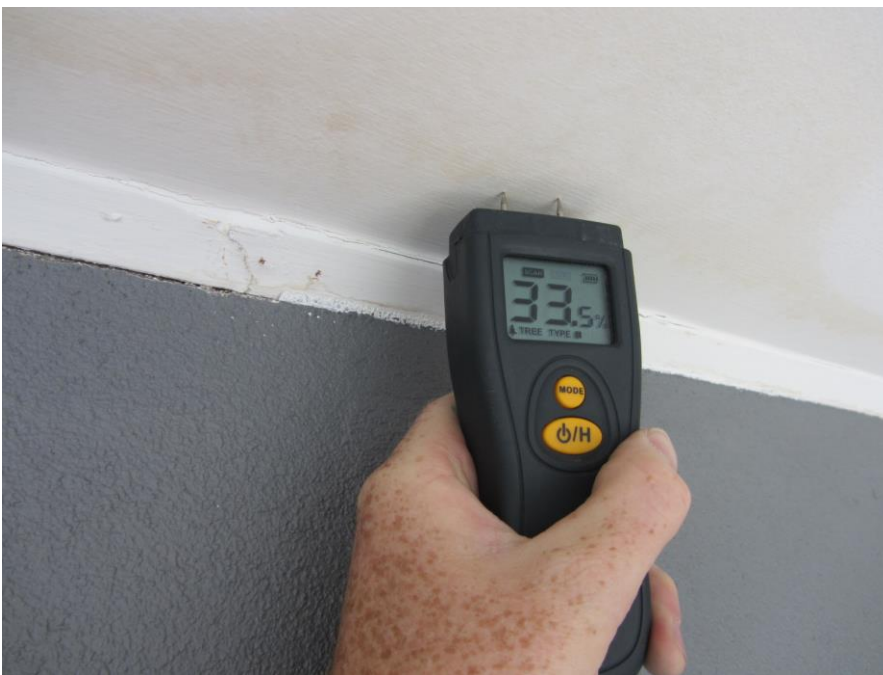
No blue dye was found following this test, however, there was a significant increase in the moisture level readings and the soffit appeared to be cool and damp to the touch indicating that water was pooling on top of the cement sheet of the soffit.

Photo 7.
The levels of moisture had significantly increased following this test.

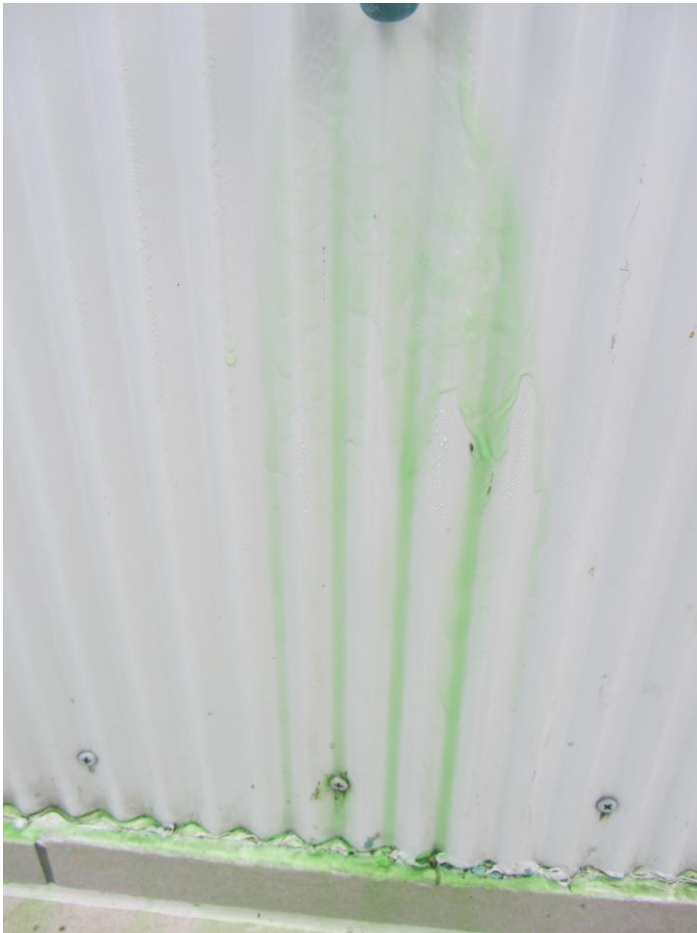
Test 4: [REDACTED] next tested the corrugated sheeting of the external wall. The sheeting has been installed incorrectly with the screws in the low parts of the corrugations instead of the high points. The issue with the screws being inserted in the low section of the corrugations is that water is channelled into the lower points of the corrugated sheets as it runs down the wall creating a possible point of water entry. Green dyed water is used for this test.

Photo 8.
Test 4 in progress.
Note how the water has been channelled into the low points of the corrugations.

No leak was found from this point.

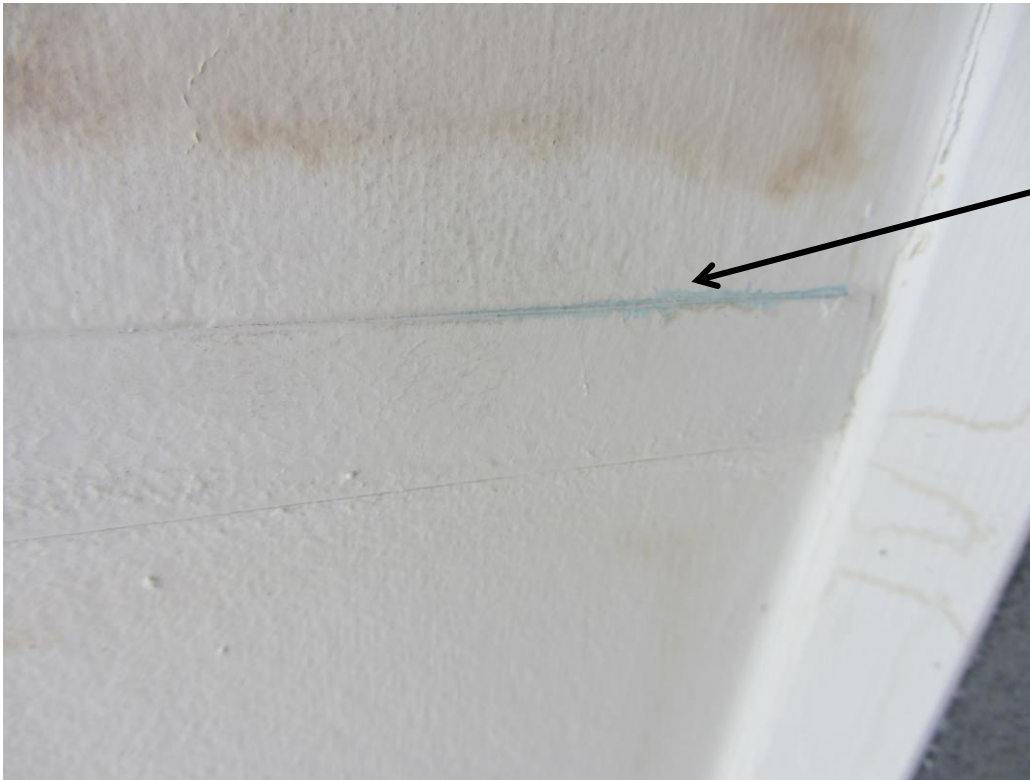
Photo 9.
Blue dye can be seen
in the soffit.

The fact that this blue dye is situated alongside a joint in the cement sheeting shows that the water is running down the joist onto the soffit. The fact that it took an extended period of time for the water to show itself in the soffit suggests that it is coming from a small, slow leak.

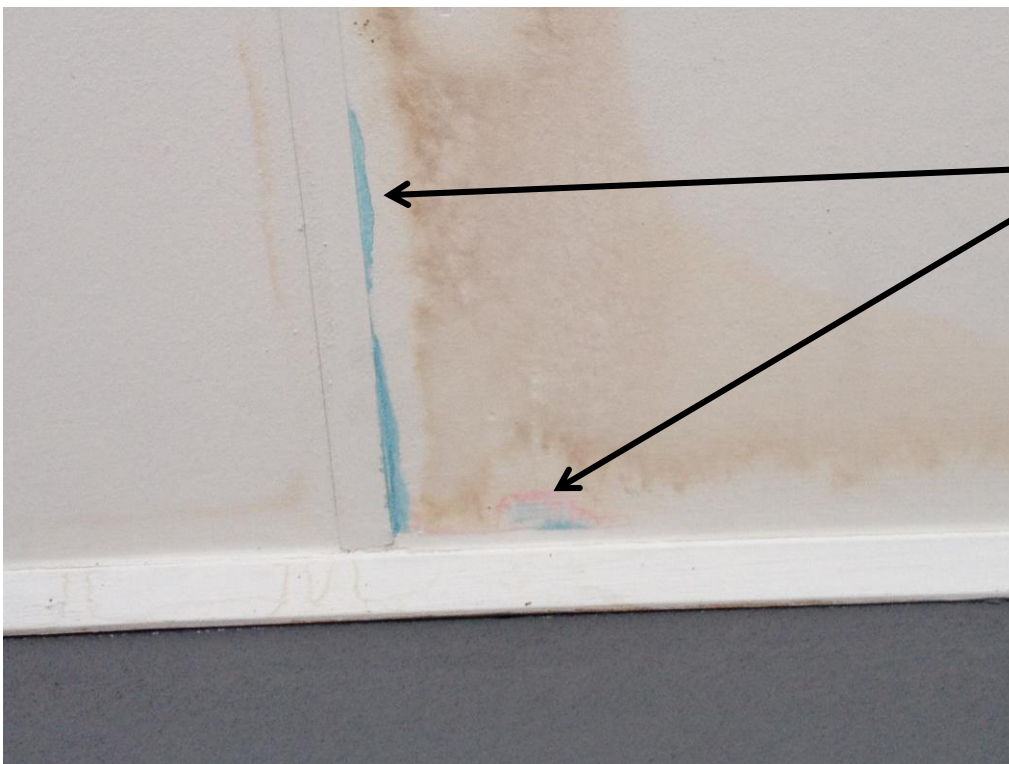
Photo 10.
Blue and red dye was
seen on the soffit the
following day.

This provides further evidence that the water ingress is occurring slowly and that it takes a long period of time for it to display itself in the soffit.

Opinion: [REDACTED] feels that the water ingress to unit [REDACTED] of [REDACTED] is coming from the sliding door and frame on the balcony of unit [REDACTED] above. The lack of any weep holes in the frame would be contributing to the leak as water has no other way of escaping the door tracks. The combined factors of the increased moisture level readings; the cool, damp feeling of the soffit holding water and the blue dye in the soffit all provide evidence that support this finding. The fact that the leak took so long to reveal itself in the soffit shows that the water ingress is occurring slowly and that water is only seeping through the water entry point. The small amount of red dye and the fact that it wasn't until the next day that it became visible shows that again water is ingressing through a small point of entry, most likely the small gap in the caulking, and is taking a long time to make its way down to the soffit below.
